## Final Report

# Damage to ITS, Traffic Control and Roadway Lighting Equipment From Transient Surge and Lightning Strikes

FDOT Contract No. BDV30-977-09  
FSU Project ID # 034543 and 034982

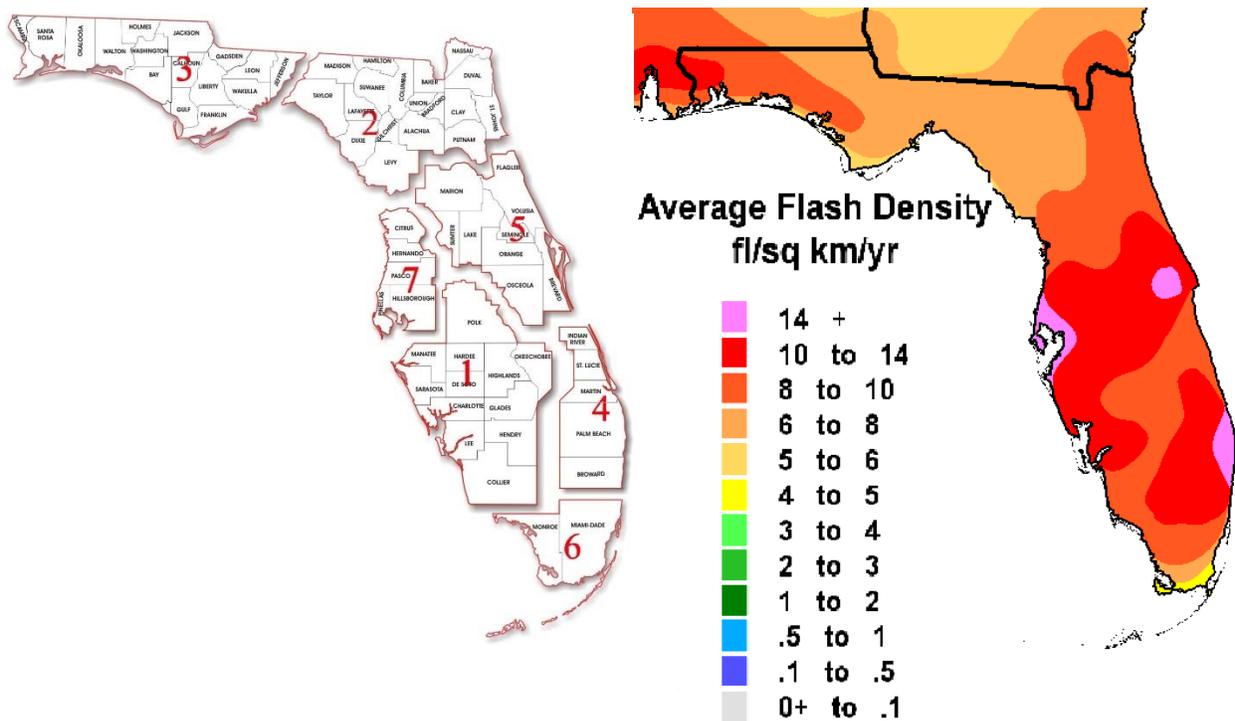
Figure 2.1. Map of the FDOT Districts 1 – 7 and the Lightning Flash Density in Florida (Vaisala<sup>2</sup>)

District 7, which has the highest average lightning flash density in the state, reported one of the lower increases in total work orders during the summer at 40%. By contrast, District 6, which had the lowest range of flash density, reported a higher increase in work orders during the summer months at 54%. The data from all districts providing ITS maintenance information in response to the survey demonstrates a significant increase in work orders or replaced devices during the peak summer lightning months. Therefore, improving the lightning surge protection measures can provide a significant savings in maintenance costs state wide.

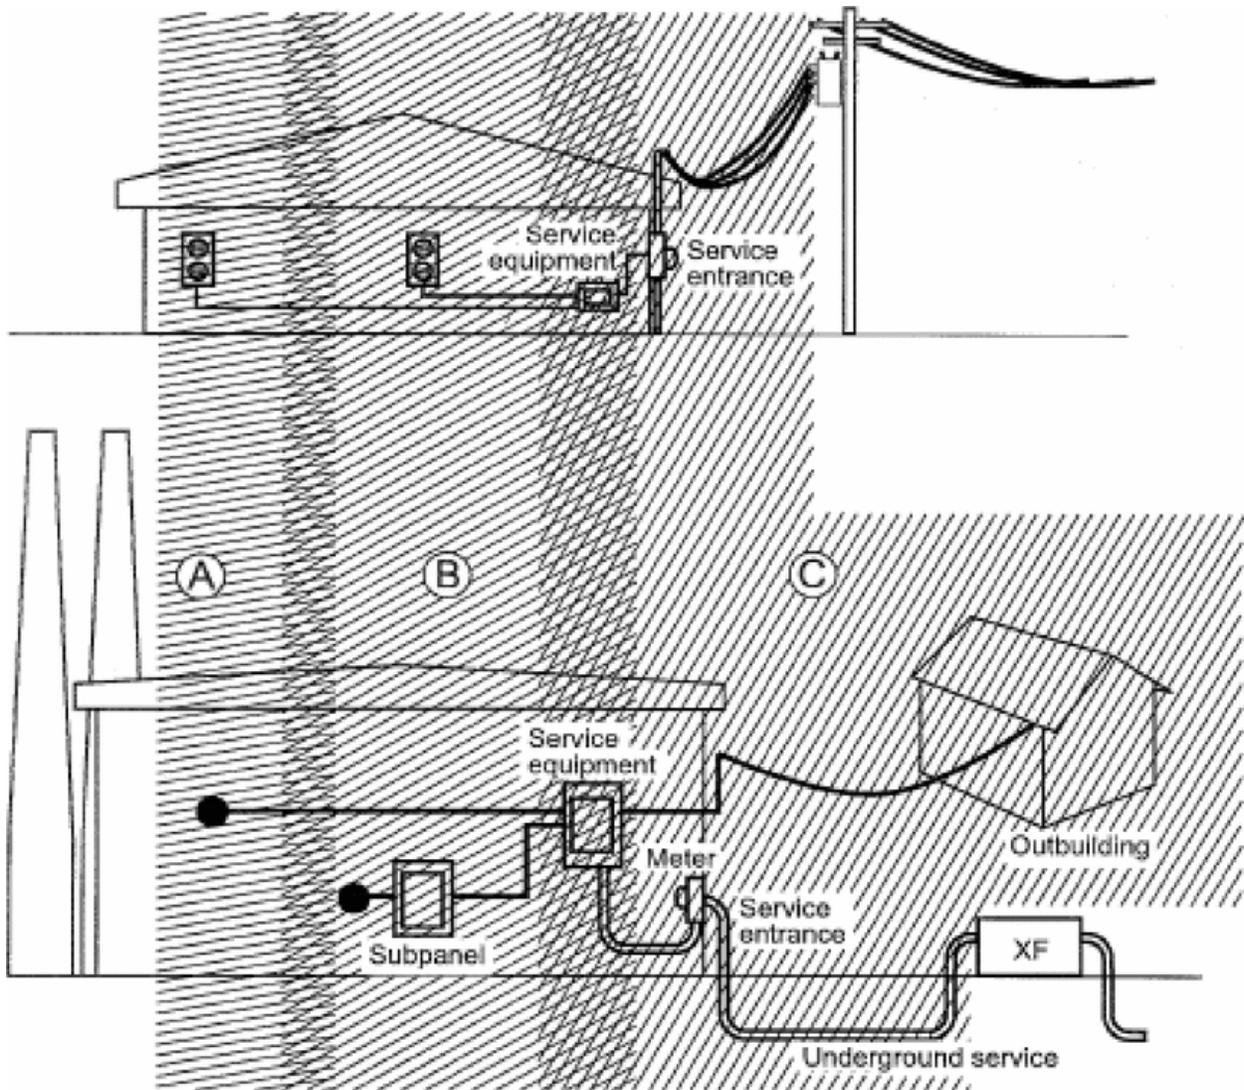
Figure 3.1. Location Category Illustration

Category A location are as follows:

- All outlets at more than about 10 m from Category B.
- All outlets at more than about 20 m from Category C.

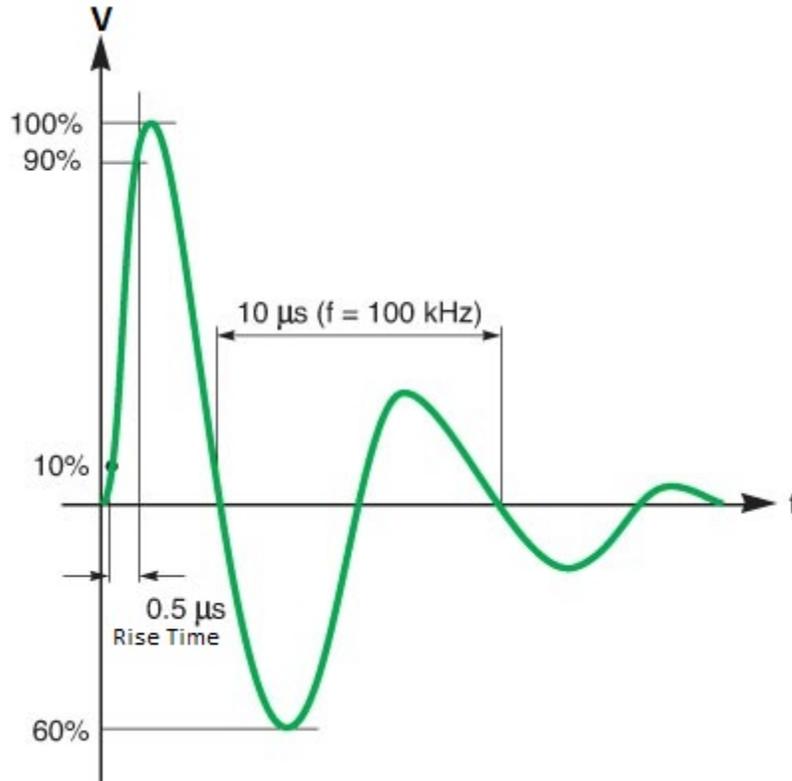
This waveform is intended to represent the switching surges and oscillatory phenomenon related to inductive effects of lightning strikes. The 100 kHz ring waveform is defined as shown in Figure 3.2. Note that this waveform has no defined current waveform. This waveform is not intended to provide high-energy stress of the SPD, but rather to test the response of the SPD to a more rapid voltage change. Tests using this waveform are designed to identify the susceptibility of the protected equipment to upset during fast transients rather than the vulnerability of the SPD (and protected equipment) to damage.

Figure 3.2. 100 kHz Ring Wave (Open Circuit Voltage)

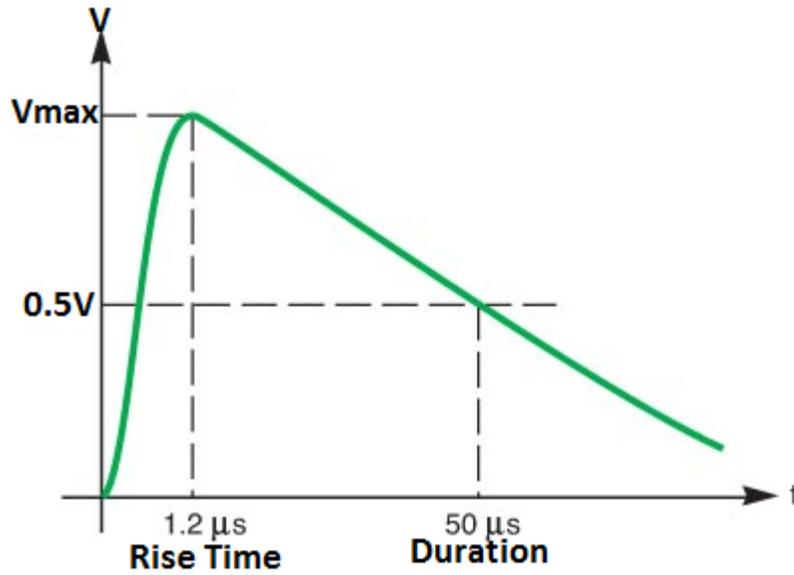
The open-circuit voltage and short-circuit current waveforms for the combination waveform are shown in Figures 3.3 and 3.4, respectively. This waveform is intended to provide high-energy stress testing of the SPD to determine the vulnerability of the SPD to damage from lightning surges.

Figure 3.3. 1.2/50 microseconds Combination Wave (Open Circuit Voltage)

- Open-circuit voltage with a rise or front time of 1.2 μs.
- A decay time to reach 50% of maximum peak open-circuit voltage is 50 μs.
- Short-circuit current rise or front time of 8 μs.
- A decay time to reach 50% of maximum peak short-circuit current is 20 μs.

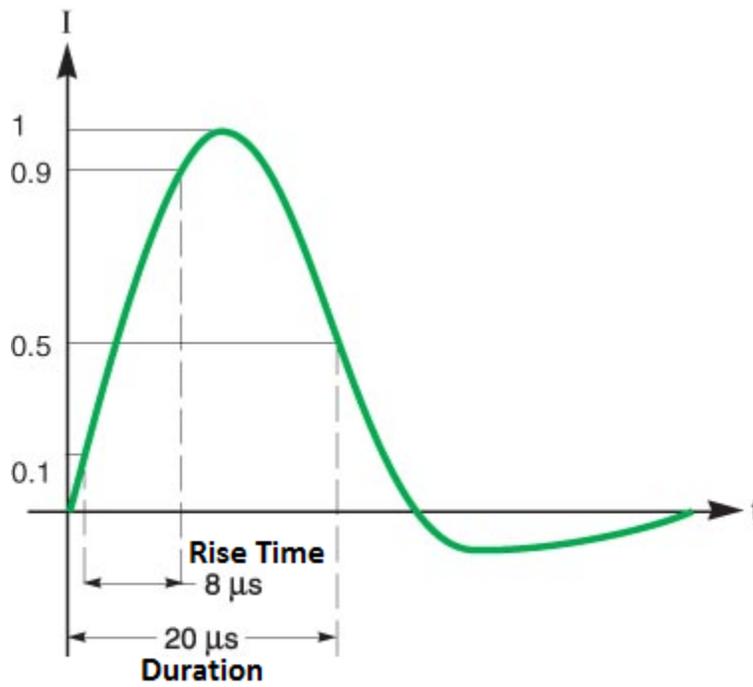
Figure 3.4. 8/20 microseconds Combination Wave (Short Circuit Current)

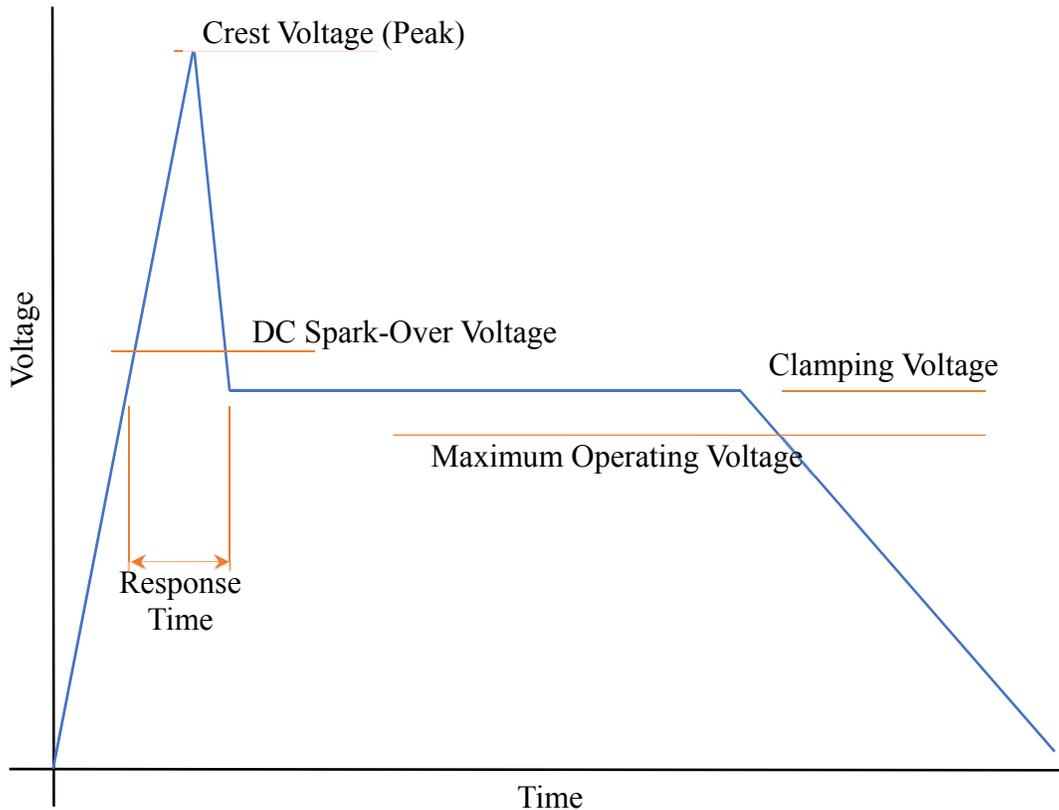
Each of the let-through voltage parameters should be measured at multiple surge currents up to the maximum rated current of the SPD. The results of these measurements shall be compared with

Figure 3.5. Simplified SPD Let-Through Waveform

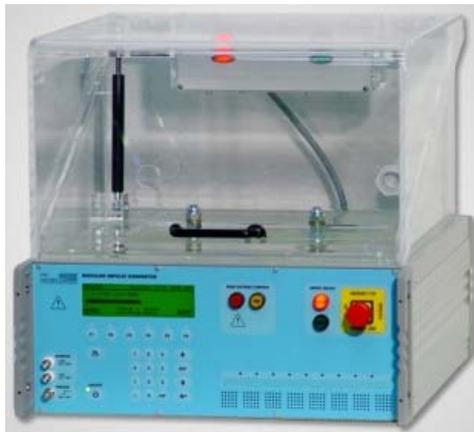
- Waveform: IEEE 1.2/50  $\mu$ s voltage, 8/20  $\mu$ s current
- Peak Open-Circuit (oc) Voltage = 6 kV
- Peak Short-Circuit (sc) Current = 6 kA
- Current Range = 0.25 to 6 kA in 1 Amp steps
- Polarity = positive, negative or alternating
- Internal Resistance / Source Impedance = 1 Ohms

The generator also can be programmed to execute a series of surges to test the long-term resilience and performance of SPDs.

Figure 3.6. MIG0606 Surge Generator with TC-MIG24ED Cabinet

A MIG0606 generator with the TC-MIG24ED cabinet had already been acquired by the FDOT for use in previous projects. Therefore the existing generator only required updated calibration for use in this current effort.

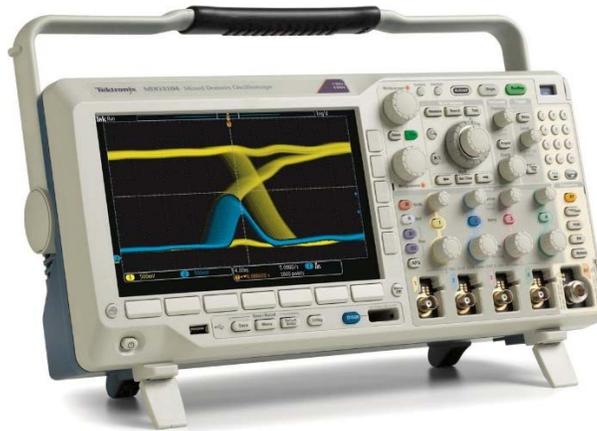
- Analog Bandwidth = 200 MHz
- Number of Channels = 4
- Sample Rate = 2.5 GS/s
- Maximum Input Voltage = 300 Vrms (using 10:1 standard probe)
- Input Impedance = 1 M $\Omega$ , 50  $\Omega$  or 75  $\Omega$
- 2 USB ports for mass storage devices, printing and control

The MDO3024 has multiple options including 16 digital inputs, arbitrary function generator and a spectrum analyzer making it a flexible instrument that is useful for other potential measurements and testing.

Figure 3.7. Tektronix MDO3024 Mixed Signal Oscilloscope

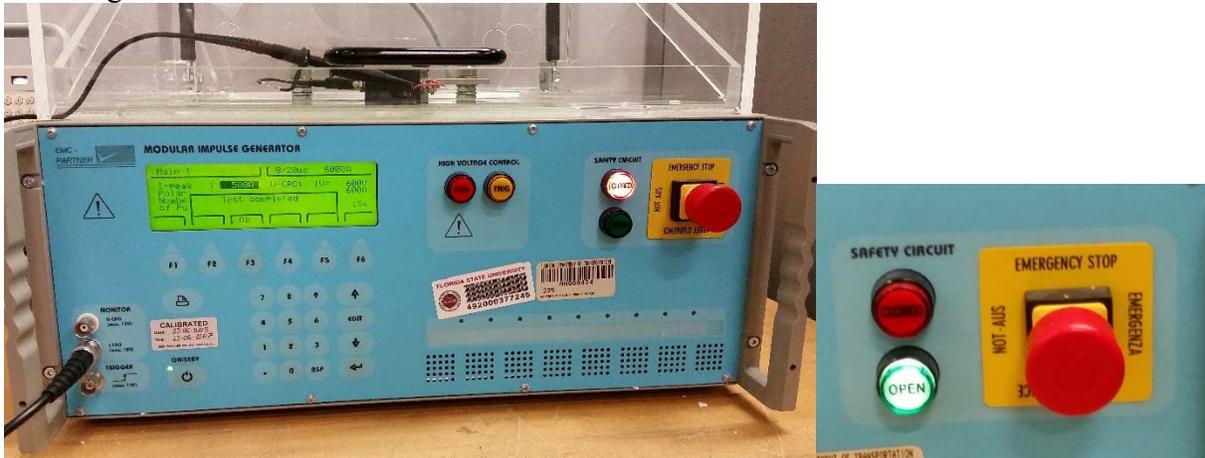
1. Turn on the oscilloscope and the surge generator, and verify that the Emergency Stop button on the surge generator is activated (pressed). The green light, “OPEN”, will be on if the Emergency Stop button is activated and it is safe to open the safety cabinet. See Figure 3.8.

Figure 3.8. Surge Generator and Emergency Stop (button presses with green light on)

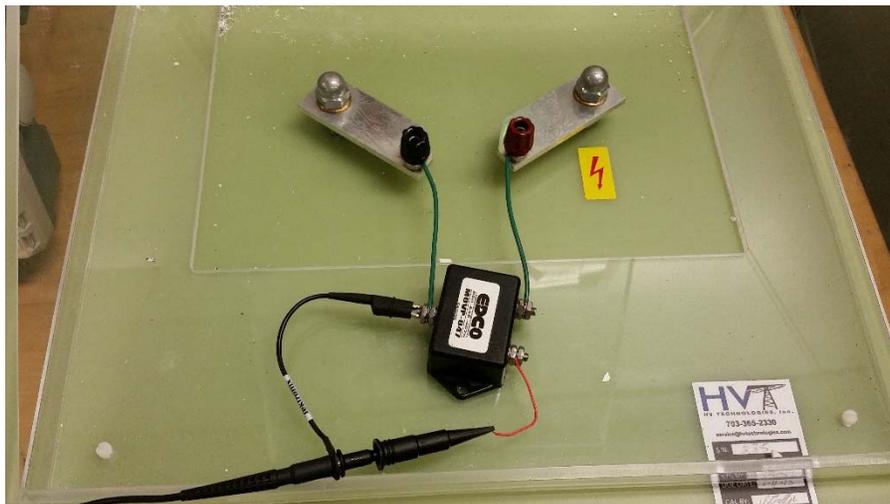
2. Place the SPD under test inside the safety cabinet and connect the surge generator terminals to the input of the SPD. Connecting wires should be 16 AWG or larger (14 AWG or 12 AWG), and the wires should be as short as practical and free of unnecessary loops.
3. Connect the oscilloscope probe to the output of the SPD. This will require the end of the oscilloscope probe to be placed within the safety cabinet of the surge generator. Use the 10:1 probes provided with the oscilloscope. See Figure 3.9.

Figure 3.9. SPD Connected to the Surge Generator with Oscilloscope Probes

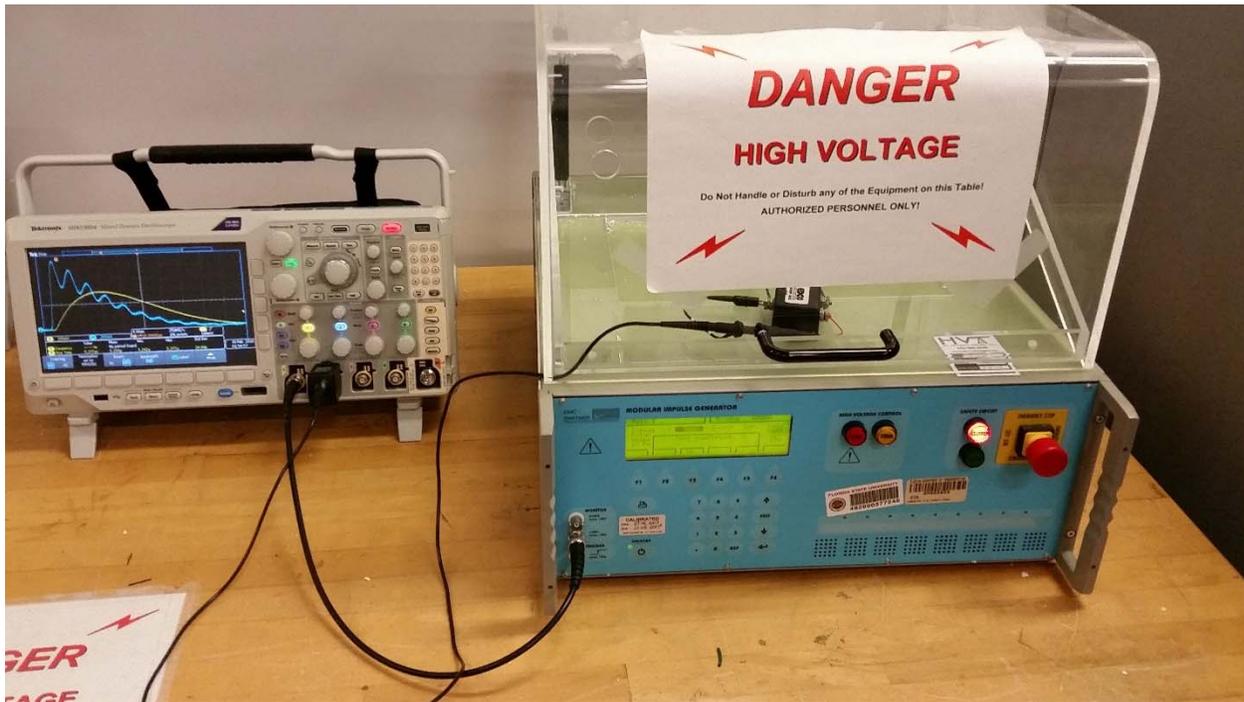
6. Set the surge generator to produce a single positive 500 A surge pulse. Pull the Emergency Stop button (red “CLOSED” light illuminates) to make the surge generator active. Start the test by pressing the red “RUN” button on the surge generator. **\*\*\*CAUTION\*\*\*** The generator will now charge internal capacitors and then trigger a surge. **Do not touch the equipment or wires until the surge is complete and the Emergency Stop button has been pressed.** Figure 3.10 depicts the test equipment set-up with an example capture SPD output on the oscilloscope.

Figure 3.10. Surge Test Equipment Setup with SPD Output Displayed on the Oscilloscope  
Note: The surge current waveform (scaled 1V per 500 A)  
was used for triggering and also displayed in yellow.

7. The SPD let-through voltage parameters are then determined from the oscilloscope display or the data downloaded from the oscilloscope.
8. Repeat Steps 1 – 7 for multiple surge magnitudes (up to the specified maximum surge current) and both positive and negative polarity.

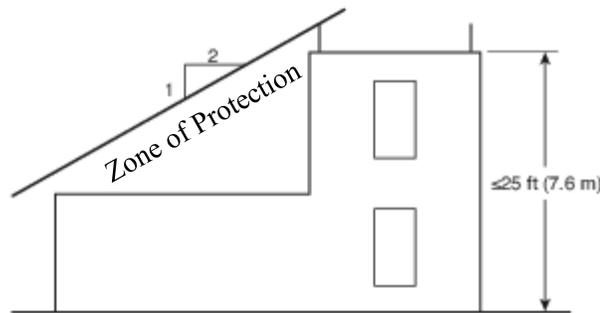
**Angular Method** - The angular method is considered to be the older method to determine the placement of strike termination devices. It is based on similar technical grounds as the rolling sphere method and can be used as a simplified (and conservative) method to determine the zone of protection for structures up to 50 ft. in height. For structures having height less than 25 ft, a 60 degree or 1:2 angle method is used as shown in Figure 4.1 to identify the zone of protection from direct lightning strikes. Whereas, for structures between 25 ft. and 50 ft., a 45 degree or 1:1 angle method is used to determine the placement of strike termination devices as shown in Figure 4.2. The zone of protection for the angular method is the area below the sloped lines from the higher air terminal shown in Figures 4.1 and 4.2.

Figure 4.1. Lower Roof Protection for Flat-Roof Buildings 25 ft or Less in Height

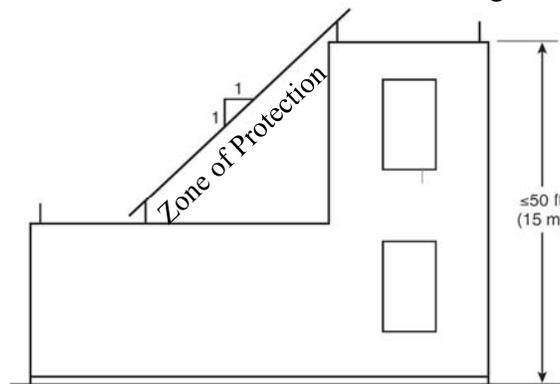
Figure 4.2. Lower Roof Protection for Flat-Roof Buildings 50 ft or Less in Height

Note that the zone of protection determined using the angular method (for structures up to 50 ft.) is a conservative estimate of the zone of protection determined using the RSM. Any object within the zone of protection determined by the angular method will also be within the zone of protection determined using the RSM. Therefore, the angular method can be used for FDOT roadside installations with heights up to 50 ft.

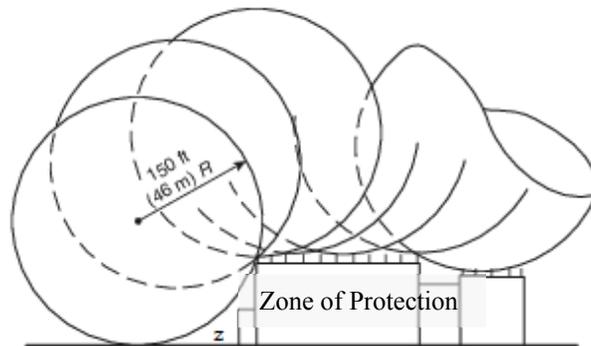
The RSM is a simplified or visual implementation of the EGM. An imaginary sphere of radius  $R = d_s$  (typically,  $R$  is 150 ft. or 100 ft.) is rolled over the structure such that the sphere is tangent to the earth and resting on all the termination devices (see Figure 4.3). All the area under the rolling sphere between points of contact with the earth is the zone of protection provided by the structure and the lightning protection system. Using the RSM, a designer can select the number and locations of air terminals or other lightning terminations to provide the desired zone of protection.

Figure 4.3. Zone of Protection Using Rolling Sphere Method

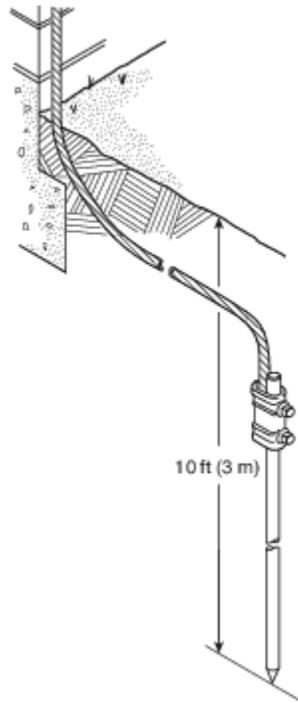
The length of ground rods shall not be less than 8 ft. (2.4 m) in length, and have a minimum diameter of 1/2" (12.7 mm). The ground rods shall extend vertically not less than 10 ft. (3 m) into the earth. The earth shall be compacted and made tight against the length of the conductor and ground rod, as shown in Figure 4.4. Rods should not be covered with any insulating material.

Multiple ground rods may be used to achieve the desired ground resistance especially in sandy soil conditions. When using multiple ground rods, the separation between any two ground rods shall be at least the sum of their driven depths, where practical. The standard also recommends that multiple ground rods be connected by ground loop conductors with the same requirements as the main grounding conductors. This recommendation is a requirement if the structure is over 60 ft. in height.

Figure 4.4. Single Ground Rod Installation

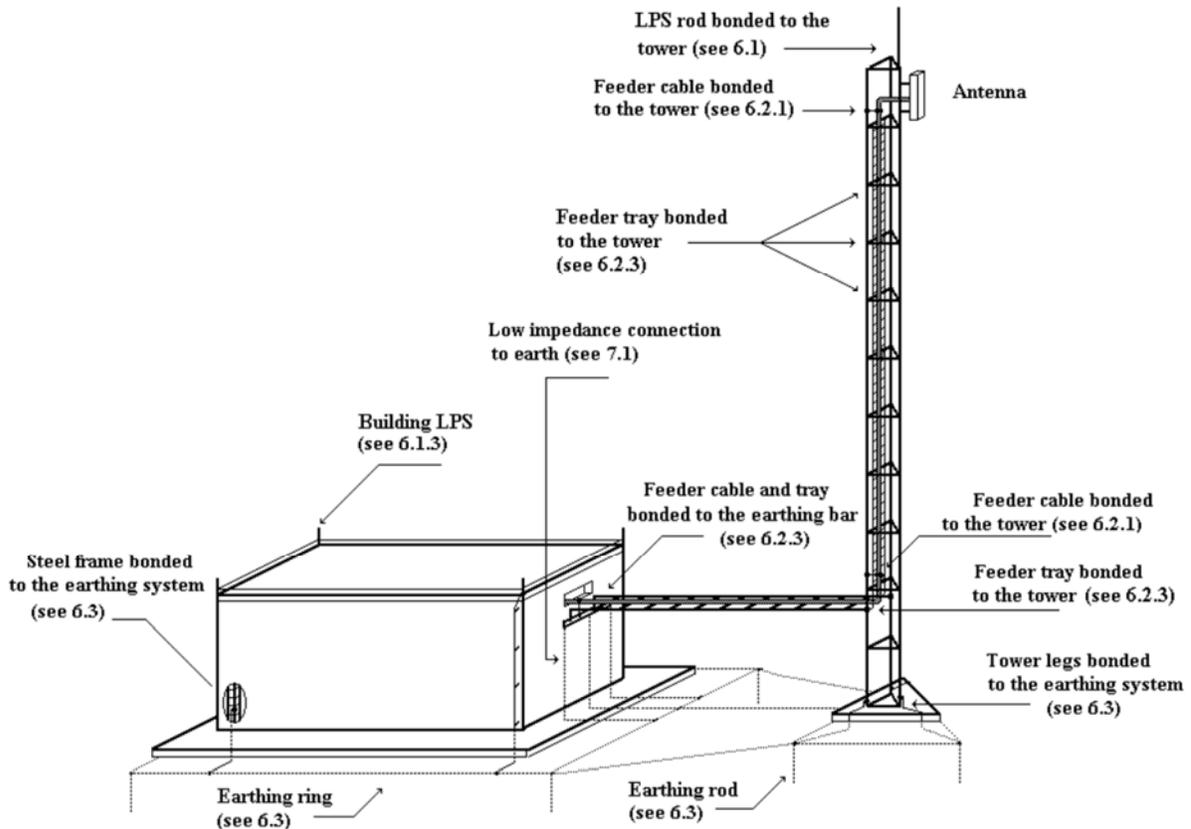
The general view of telecommunication tower and the radio base station presented in the ITU-T K.56 recommendation is shown in Figure 4.5. The sections referred to in this figure are the specific sections of ITU-T K.56. This structure is similar in structure to a CCTV or MVDS pole, DMS structure, or roadway lighting pole connected to a detached (or even attached) equipment cabinet. The recommendations in the ITU-T K.56 will be summarized below with respect to its applicability to the FDOT roadside installation lightning protection. Comparisons between the ITU-T K.56 recommendations and related requirements in the NFPA 780 standard will be included.

Figure 4.5. View of External Lightning Protection for a RBS and Telecommunication Tower

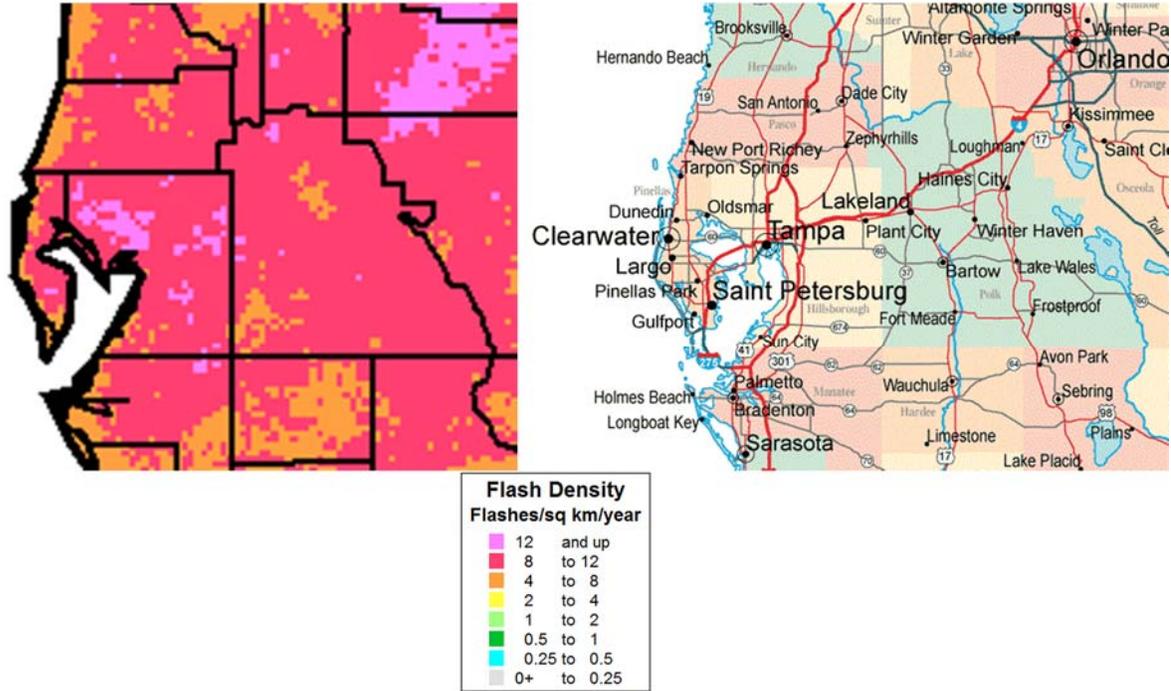
According to the records provided by FDOT District 7, the MVDS installations on I-4 from mile marker (MM) 3.5 to about MM 22.4 (Hillsborough County) were installed without air terminals on the concrete poles. The MVDS installations on concrete poles from MM 22.4 to MM 54.1 (Polk County) were installed with air terminals installed. Figure 4.6 shows the lightning flash density (average flashes/km<sup>2</sup>/year for 2005-2014) and highway map for west central Florida, including Hillsborough and Polk counties. In Figure 4.6, it can be seen that I-4 in Polk and Hillsborough counties is within a high lightning density area. However, the lightning density in Polk County is 10 – 20% lower than in Hillsborough County. Therefore, within this test site, the area where the MVDS poles have air terminals (MM 22.4-54.1, Polk County), there will be 10–20% less likelihood of lightning strikes than in the area where the MVDS poles do not have air terminals (MM 3.5-22.4, Hillsborough County). This will have to be taken into account in the final assessment of the forensic maintenance comparison.

Figure 4.6. Lightning Flash Density and Highway Map for West Central Florida (Vaisala)

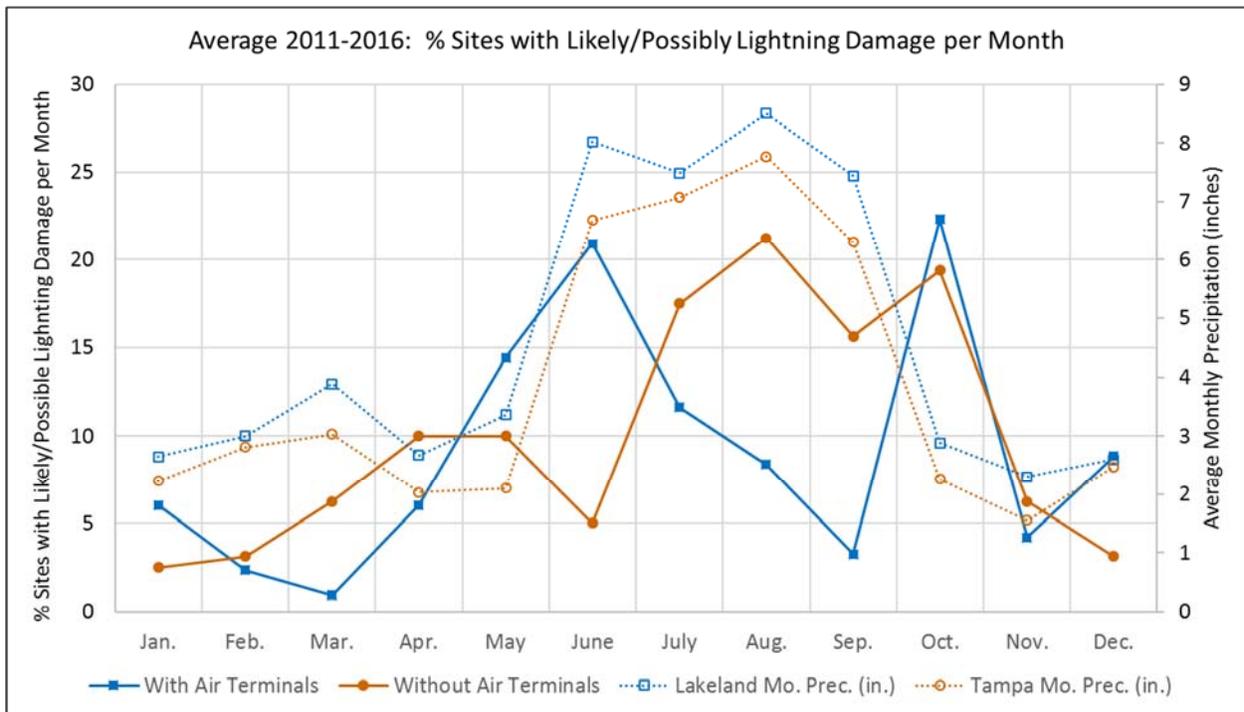
The counts in each category were averaged over the five years of data for each month (January – December). Then the assessment focused on those maintenance reports that were categorized as either possible or likely lightning damage, and attempted to determine if there was a difference in the increase in lightning damage during the summer lightning months between those sites with air terminals and the sites without air terminals. Separately for the sites with and without air terminals, the sum of the average counts possible lightning damage and likely lightning damage in each month was divided by the total number of sites (43 sites with air terminals and 32 sites without air terminals) to determine the “% Possible & Likely Lightning Damage” per month. The results are plotted in Figure 4.7.

Figure 4.7. Average Percentage of Sites with Likely of Possible Lightning Damage Per Month

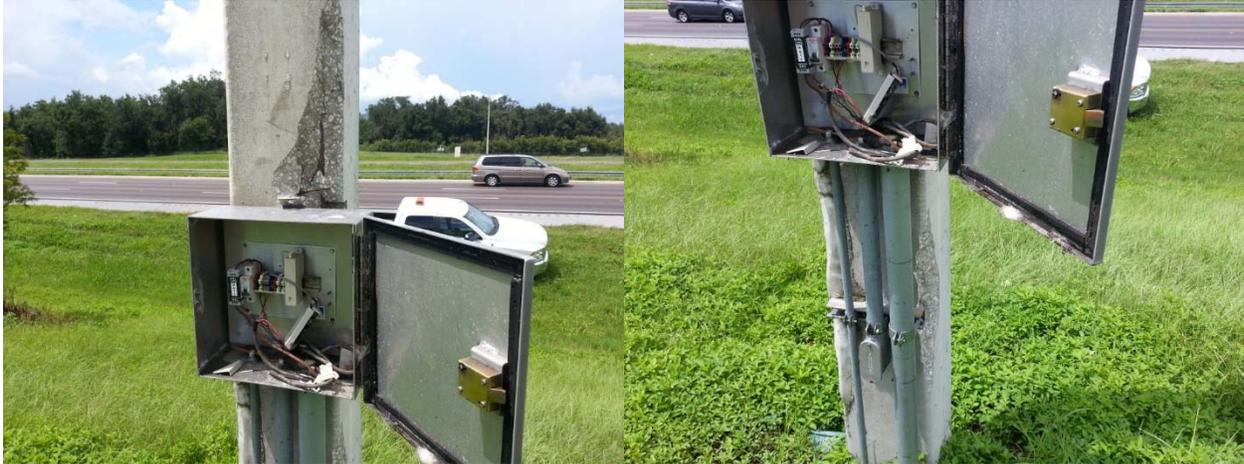
Air terminals are primarily designed to add protection from a direct lightning strike to the installation. In the 5 years of the maintenance review, only one site was indicated as having experienced an obvious direct lightning strike. The MVDS site eastbound on I-4 at MM 15.8 experienced a direct strike that caused significant structural and electronic damage (see pictures of some of the damage in Figure 4.8). This site did not have an air terminal. It appears that the reinforcing steel in the concrete column became the down conductor and the current arced to the attached cabinet and conduit support causing physical damage to the concrete pole. Also, the electronics within the cabinet was severely damaged.

Figure 4.8. Direct Lightning Strike Damage to MVDS site at MM 15.8 on I-4

There is no way of determining if other direct lightning strikes occurred at sites where the air terminals successfully grounded the current avoiding visible damage. However, this is the only direct strike reported by District 7 in any of the 32 sites without air terminals over the 5 years of maintenance data provided. Reliable statistics are not possible with only one incident, but this is an average of one direct strike per year for every 160 MVDS sites without air terminals.
